Ref: CA-002-001 Report of the Harrison Cemetery Restoration

Please find enclosed my final report of methods and results of the mapping and stone repair of the Harrison Cemetery located at 340 Cox Road, Huntingtown, Maryland.

Per my proposal dated October 1, 2007, I repaired three stones by the methods previously described. Before and after photographs are included:

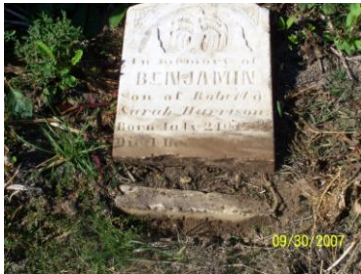
Before restoration

Benjamin Harrison

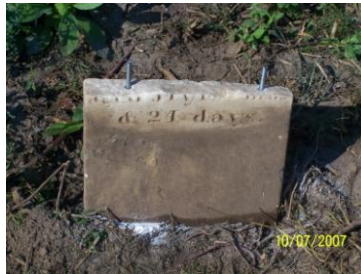
During restoration

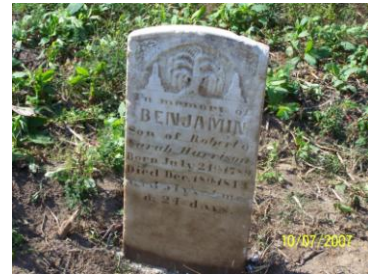
After restoration

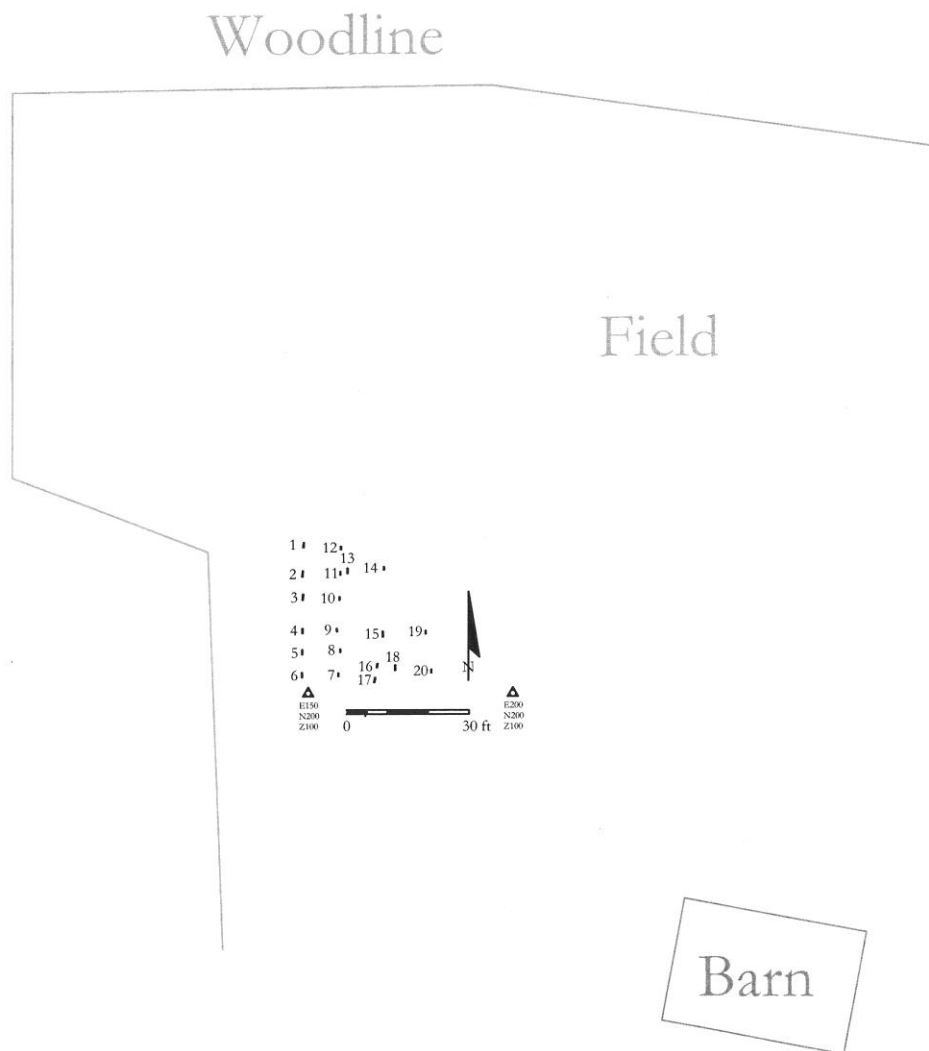
The following table and illustrations are the result of mapping and recording data. Each number represented on the maps corresponds to the number in the table.

Figure 1. General overview of the Harrison Cemetery

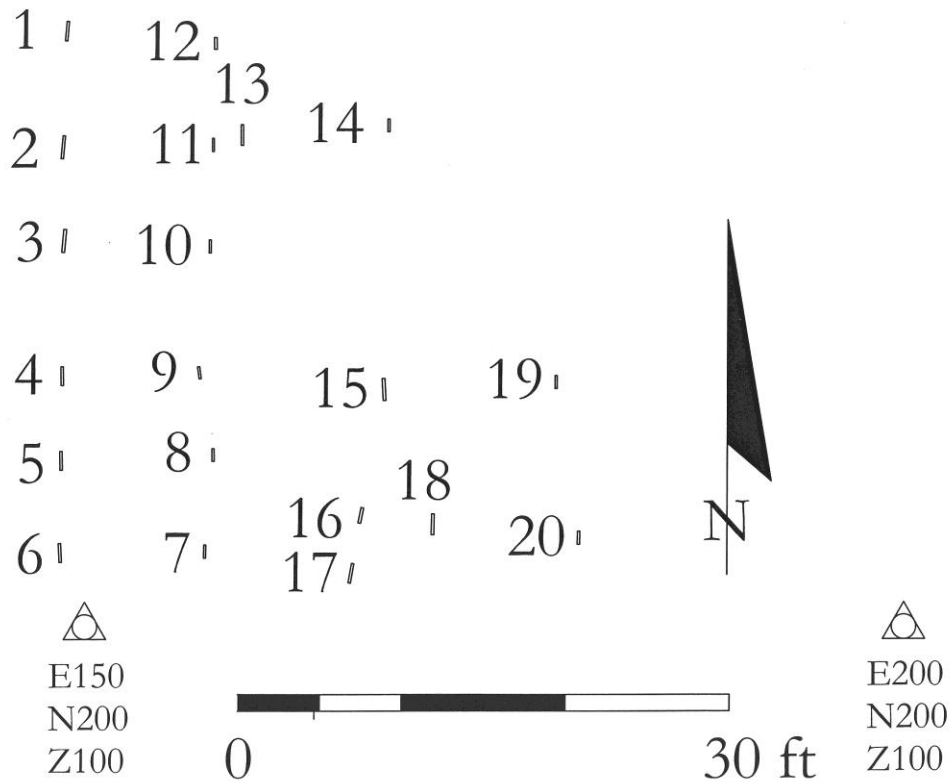
Figure 2. Detailed view of the Harrison Family Cemetery

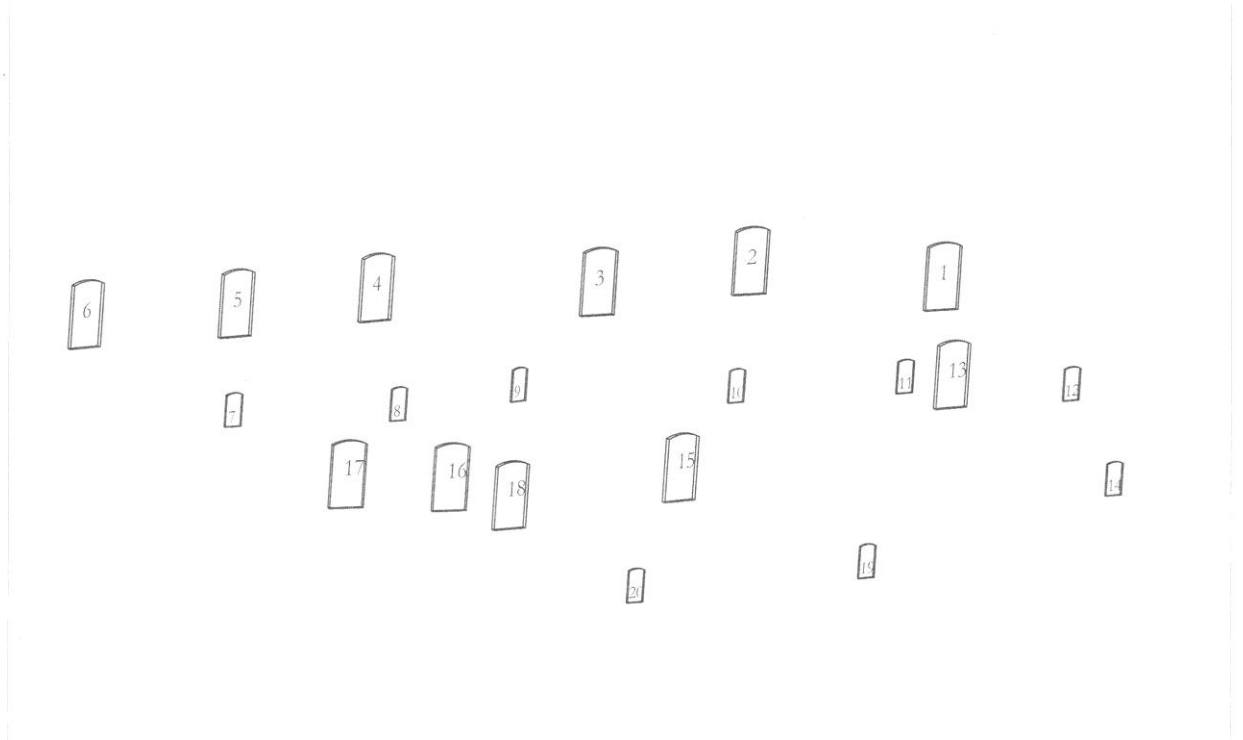
Figure 3. Three dimensional view of the Harrison Cemetery
